**+2 YEAR LINING LIFETIME ACHIEVED
IN REHEATING FURNACE**

Rolling mill achieves +2 years lining lifetime in reheating furnace with HASLE LCC lining.

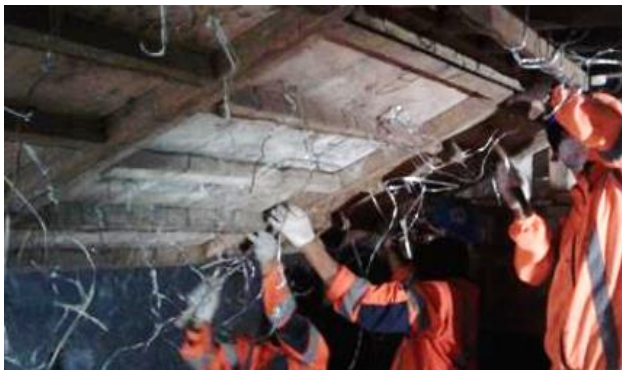
Installing formworks on furnace roof

In December 2018, they had to shut down to repair the castable in the Furnace Roof, Sidewalls and Floor. After marking the damaged Furnace Roof Area to be repaired, the area was demolished and relined with new, HASLE precast, ceramic anchor bricks. The anchor bricks are held in place using round, stainless steel bars (16mm in diameter).

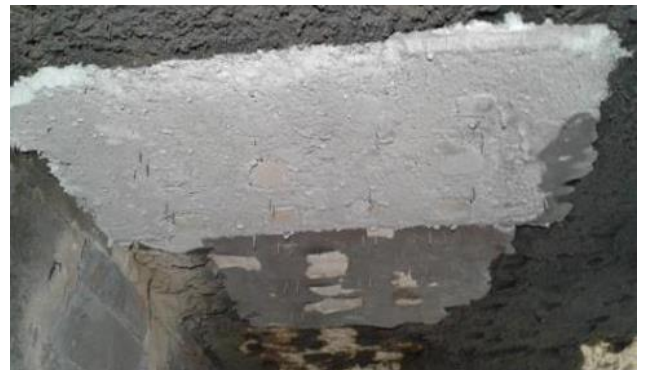
Since then, the reheating furnace has been in continuous operation. The HASLE D59A-ht castable is still in good condition and has now achieved a lifetime of more than 2 years.

Completed repair using HASLE D59A-ht

Once the bricks were in place, the repair of the furnace roof was completed using HASLE D59A-ht. Damaged areas of the side walls were also repaired using the same technique and HASLE materials. All parts of the job were executed by the installation company 360 Degrees, and fully met the high industry standards.
