**+5 YEARS IN DUST SETTLING
CHAMBER WITH HASLE D59A**

+5 years lifetime achieved in conical portion of Dust Settling Chamber

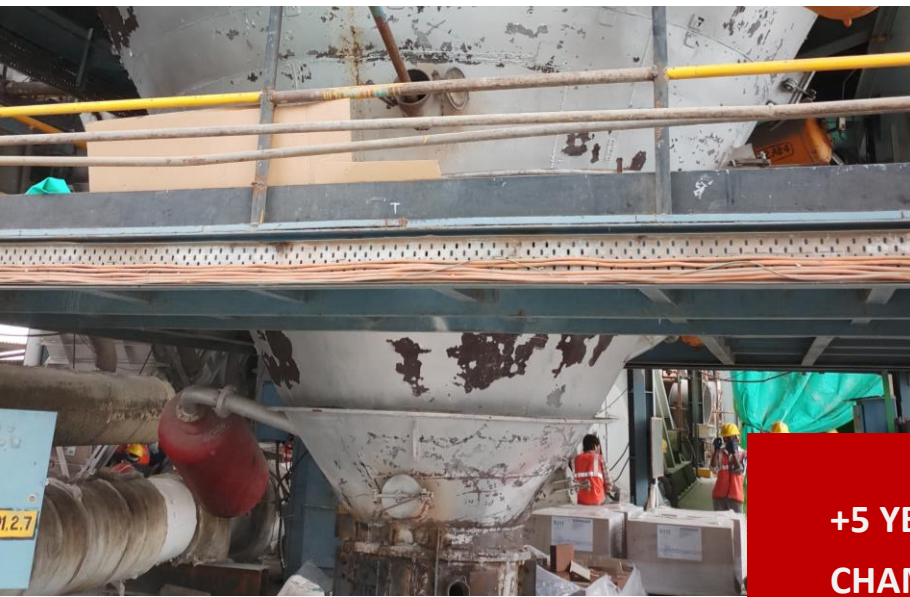
A 10000 TPD cement plant in Northern India operating on 100% pet coke was experiencing premature failure of the lining in the conical portion of their dust settling chambers due to high abrasion and material sticking in cone causing red spots. They routinely had to repair the conical portion from the outside, by placing around 15-20 stone boxes in a campaign life of one year.

We suggested trying HASLE D59A castable lining, which is highly abrasion- and coating resistant. In July 2016, HASLE D59A was applied at the conical portion of the dust settling chamber. In 2021, the lining reached an exceptional +5 years lifetime and is still in operation. In 2017, the plant decided to install HASLE D59A in the conical portion of the second dust settling chamber. This lining now has a +4 years lifetime and is also still running.

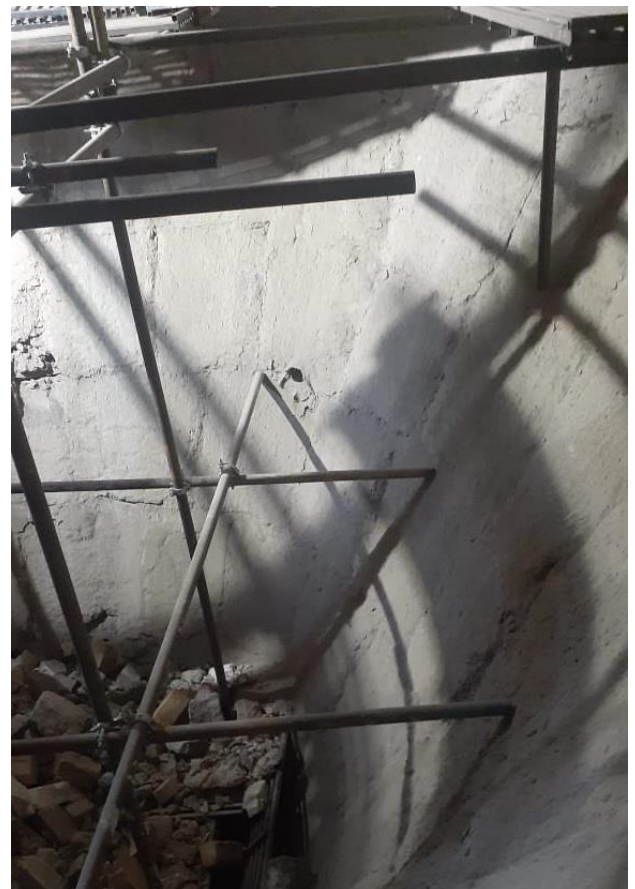
D52A in Dust Settling Chamber at inspection after 4 years
