## Indonesian Cement Plant achieves +1.5 years lifetime in Cyclone target zone

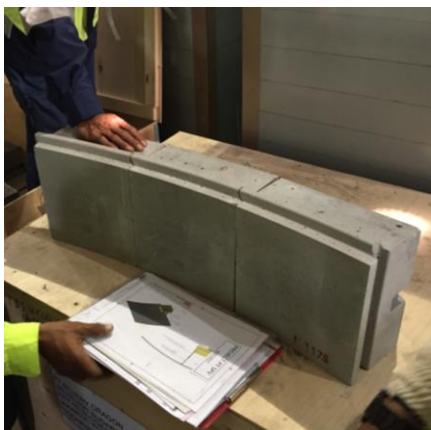
Curved Modular Lining elements

In 2017, we designed a curved version of HASLE's Modular Lining for the power plant's cyclone target

zones. Cast and pre-fired at our plant in Denmark, the cylindrical precast Modular Lining was installed in the target zones of the two cyclones.

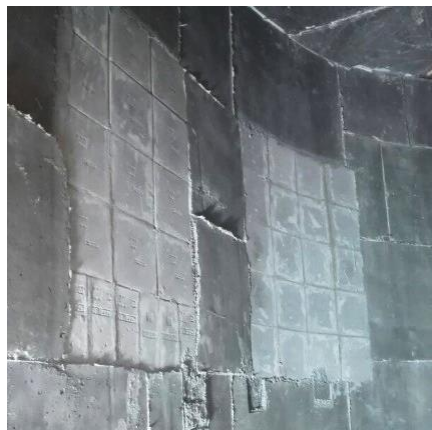
Modular Lining at installation
